Merit LILIN Application Note

NAV OS SSD Might Cause NAV Recorder Instable

Document Number : A00138 Date : 2018/01/12 Dept: Technical Support, Taipei

Subject: LILIN Nav Server. Possible instabilities discovered relating to usage of certain make/model SSD's when being used for the operating system drive. How to identify and fix any issues.

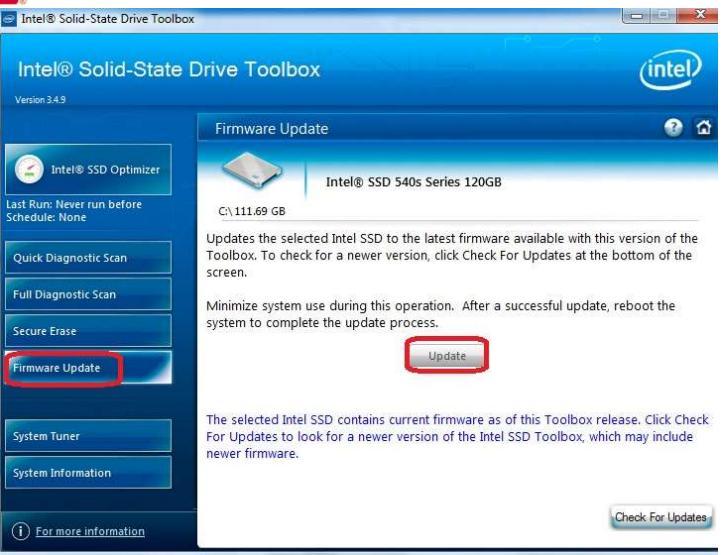
Step5. Click to see if the values of E8 & E9 are higher than 30%. If not, please RMA the SSD with the SSD manufacturer for repair.

Step6. Click the Update button to update the SSD firmware.

Step7. Reboot the PC once the firmware has updated successfully.
